3rd International Conference on Road and Rail Infrastructure
28–30 April 2014, Split, Croatia

Road and Rail Infrastructure III

ROLLING CONTACT FATIGUE ON TRAMWAY'S RAIL

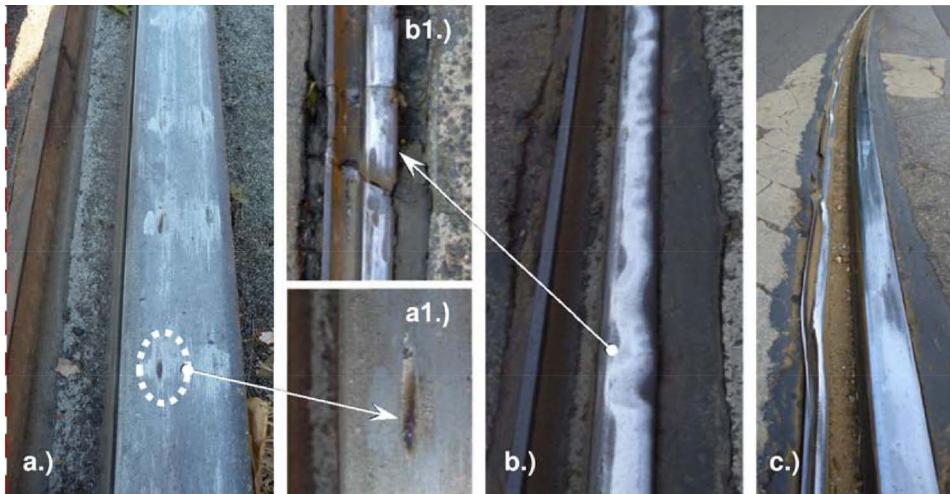
Some special defects were observed during a condition survey of Budapest tram lines carried out by the author. This condition survey was based on consultations with professionals of BKV (Budapest Public Transport Plc.) and photos taken during the perambulation of tram lines and the performed investigations. Fig. 1 shows some typical defects.

Figure 1 Special rail corrugation and defects: a) The pitch of rail corrugations was cut by electromagnetic rail-brake; b) "Winding-shaped" wear on the running surface, later broken; c) Special corrugated rail side wear of grooved head in curve

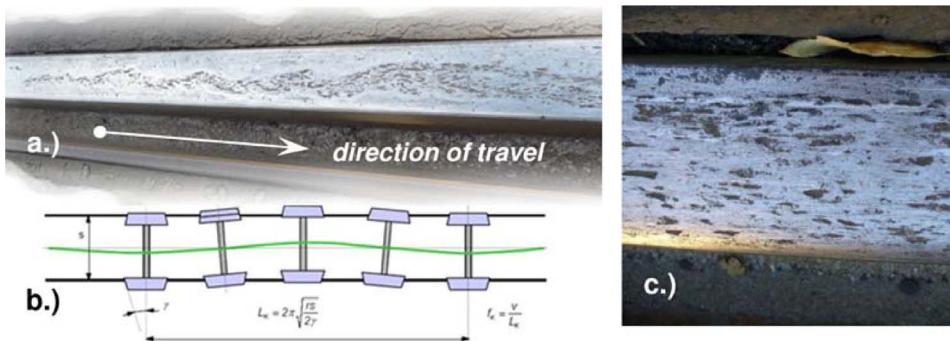
Defects apparently similar to head checking cracks (HC) were observed at starting and stopping location of the driving axle at tram stops. At these locations fatigue type defects appearing on the running surface are parallel to the track. It should be noted that longitudinal surface defects occur most frequently on the full width of rail head (Fig. 2c). However, the defect in other rail sections has a shape of corrugation (Fig. 2a). It shows similarity to the impact of unstable high-frequency bogie movement which can occur mainly on rails of high speed railways. The wheel probably slips at the moment of start and stop. This slip leads to the hardening of the rails' running surface which results failures occurring on the rail tread due to cyclical fatigue load. This type of defects was first observed by the author in Budapest, along tram line 49. The most significant defects were discovered on sections of that tram line where only aged carriages run, without slip protection equipment. These defects appeared less frequently on sections where other types of tramcar also run.

Figure 2 a) Corrugated shape of failure; c) Longitudinal fatigue defects on the whole cross-section of running surface

Geometric dimensions of a defect could be also determined from the pictures taken by a digital microscope. The length of the observed failure is varying between 5 and 25 mm (Fig. 3c) and the dominant wavelength of the displayed wave-like defect shown in Fig. 2a is between 0.10 and 0.30 m. A difference exceeding two orders of magnitude appears when this value is compared to the theoretical wavelength derived from the calculation based on Klingel’s formula [3] Eq. (1):

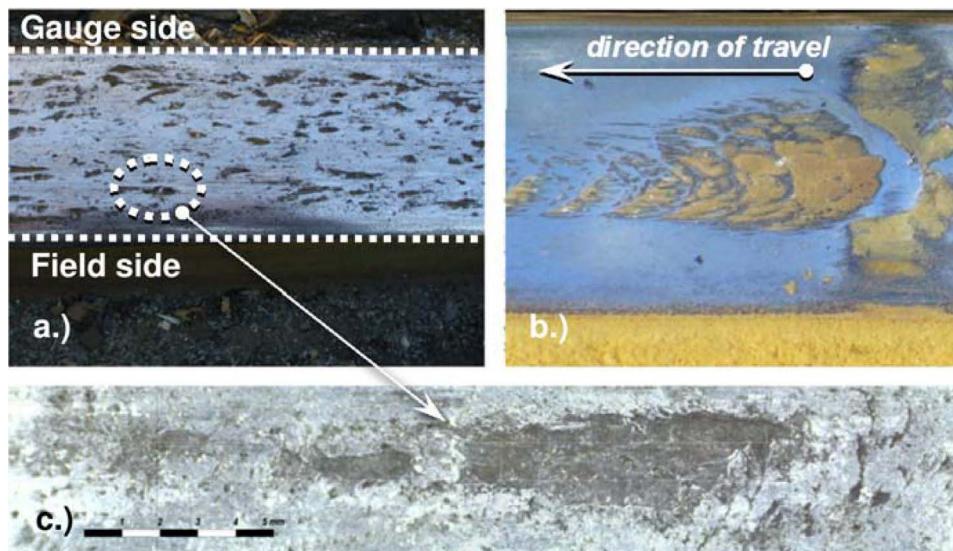
Images of digital microscope showed inelastic deformation (“micro-slip”). The microscope was controlled by a computer, which immediately recorded the photos taken with appropriate lateral overlap, so the microscopic pictures can be joined easily by using an appropriate software. Fig. 3c shows a panorama photo of the discovered defect. Surface deformation of the displayed microscopic failure (Fig. 3c) shows similarity to the “comet-shaped” rail surface macro corrugation caused by high-intensity acceleration, where the direction of the movement can be also determined easily (Fig. 3b).

Figure 3 a) The longitudinal failures; b) macro “comet”- shaped defect on the rail running surface c) Panorama photo of digital microscope

The most significant defects were discovered on those sections of the tram line stops, where the driving bogies stop. Surface deformations discovered (Fig. 3c) showed similarity to the “comet-shaped” rail surface macro corrugation, caused by high-intensity acceleration. During wheel slip testing, the tramcar does not slip in a visually perceptible manner, but the detailed investigations showed micro-slip directly proportional to distance. Furthermore, the lengths of the defects were equal to the measured slip values at the moment of start. On the base of these facts it can be assumed, that probably the slip plays an important role in the formation of these defects. The uncertainty of the wheel slip testing is reduced by applying wheel-mounted digital 3-axis accelerometer, which ensures the continuous monitoring of the wheel motion. Although the measurement methodology has already been developed, actual measurements on the field are planned to be performed in spring 2014.

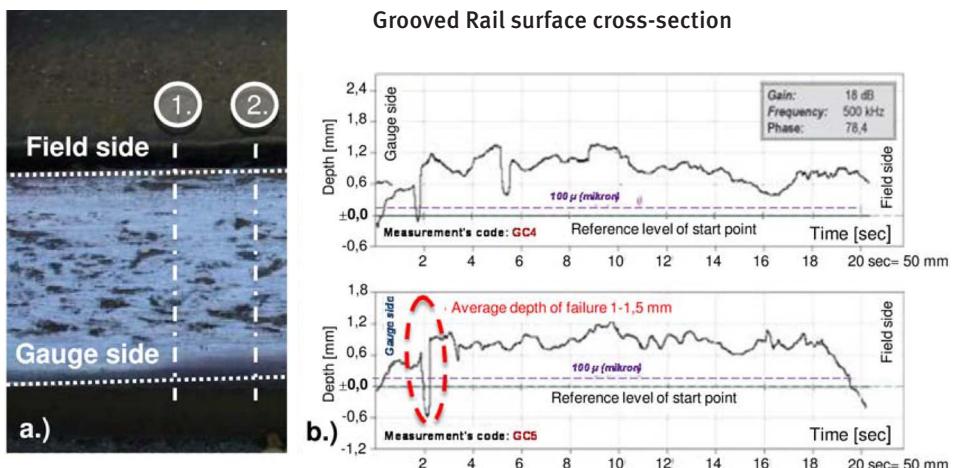
Figure 4 Testing result of two cross-sections by using Eddy current sensor

Measurements were performed using Hocking Locator 2, a single frequency device. The Eddy current test method is based on the principle of magnetic induction. The primary magnetic field of the excitation coil (sensor) induces a secondary magnetic field in the rail. Measuring the changes of this magnetic field the location of sub-surface cracks and material failures can be determined. The sensor is moved with constant speed transversally on the rail's running surface (the width of a rail head is measured in 20 seconds). This timebase mode crack detection test was performed in those cross-sections, where the size of the defects was the greatest (Fig. 4a). In the time-base mode the Y component (depth) is represented against time. Near-surface cracks were not discovered by using Eddy current sensor.

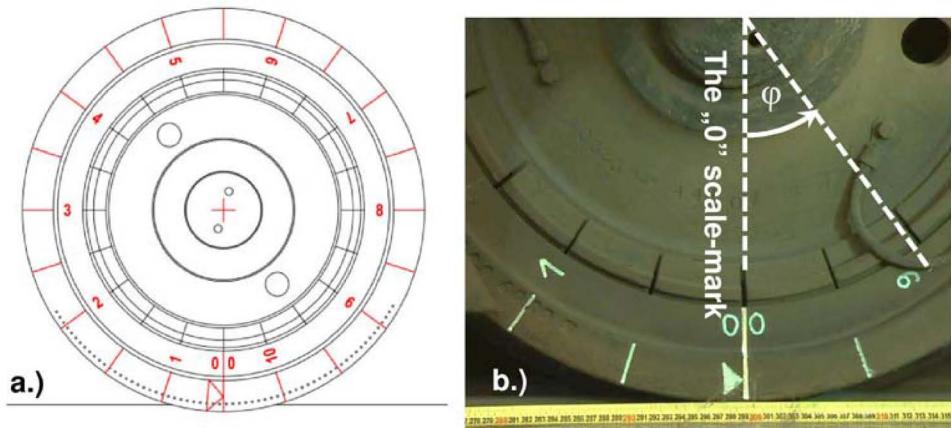
The results of these investigations (Sections 1.1.1 – 1.1.3) lead to the conclusion that the wheel micro slip (Section 1.1.1) can play a significant role in the appearance of the defect described above (Fig. 2), therefore the slip values were determined at the moment of start and stop of the tramcar, under operating conditions. The tests were performed on a back storage track of tram depot in Budapest under dry, cold weather and good adhesion condition. The tramcar used for the test runs on that line, where the observed failure is situated. (Section 1.1 refers to main parameters of the tested tramcar). Scale signs were marked up on the wheel and along the track before the measurements, therefore the slips become easily determinable by visual observation (Fig. 5).

Figure 5 a) Regular scales marked on the wheel; b) the “0” scale-mark and the scale-marks placed alongside the track

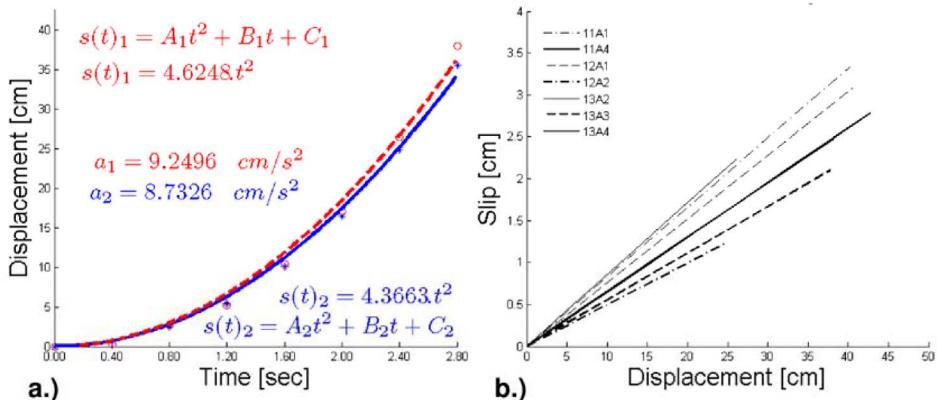
Figure 6 a) Time – distance, and time–angular displacement functions in case of starting by high intensity acceleration; b) distance – slip diagram in case starting by various intensity acceleration

Fig. 6a shows the parameters of the fitting curves in case of a start with high intensity acceleration (the Quadratic Regression Equation = ax^2). The residual values (difference between the fitting curve and the actually observed values) are caused by imperfection of reading from scale-marks alongside the track. The slip value (Δs) is determined by the difference of fitting curve Eq. (2):

The measured and calculated slip values at the start reflected micro-slip that is directly proportional to distance (Fig. 6b). This could be caused by the linear engine of the tramcar, which assures uniformly accelerated motion.

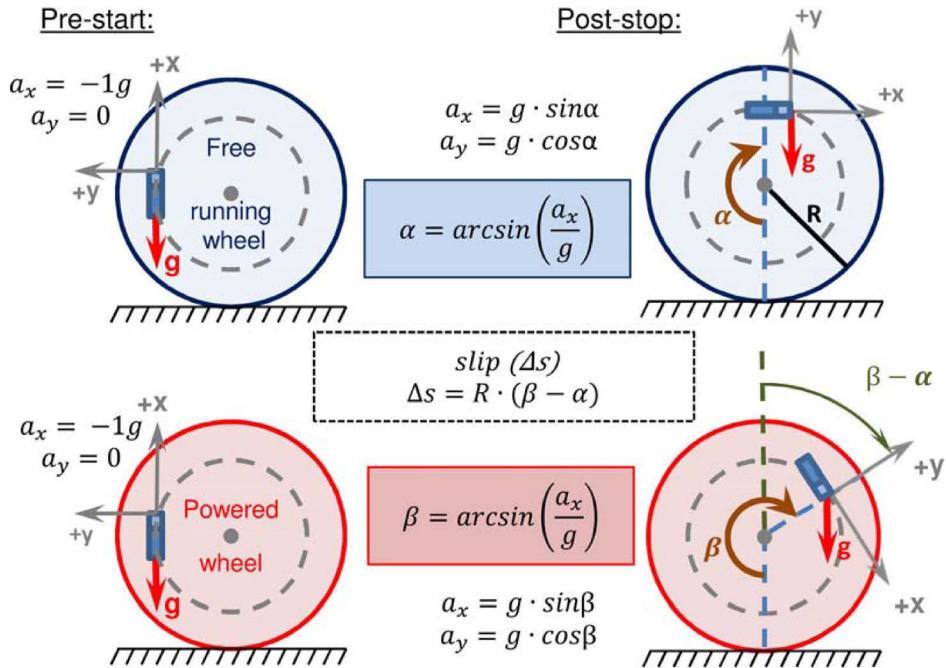
The accelerometers are placed preferably in identical position on the wheels (they should be in equal phase – cophasal-) before starting. The magnitude of wheel slip can be determined from the “pre-start” and “post-stop” angle differences of the accelerometer positions by using accelerometer values (a_x, a_y) (Fig. 7). The directly measured acceleration data is distorted by noise, while that latter could be separated from the data by using linear-phase low-pass digital filter [4] in MATLAB. Fig. 8 illustrates the filtered signal and the acceleration, braking and coasting sections in case of a starting with low-intensity acceleration. The magnitude and location of the slip is determined from the phase shift of the measured accelerometer data read on different wheels. It can be noted that the calculation must be corrected, because of the difference between the accelerometer run circuit and the length of tread. Further tests with a properly equipped tramcar are planned to be performed in spring 2014.

Figure 7 Wheel slip testing by using 3-axis accelerometer

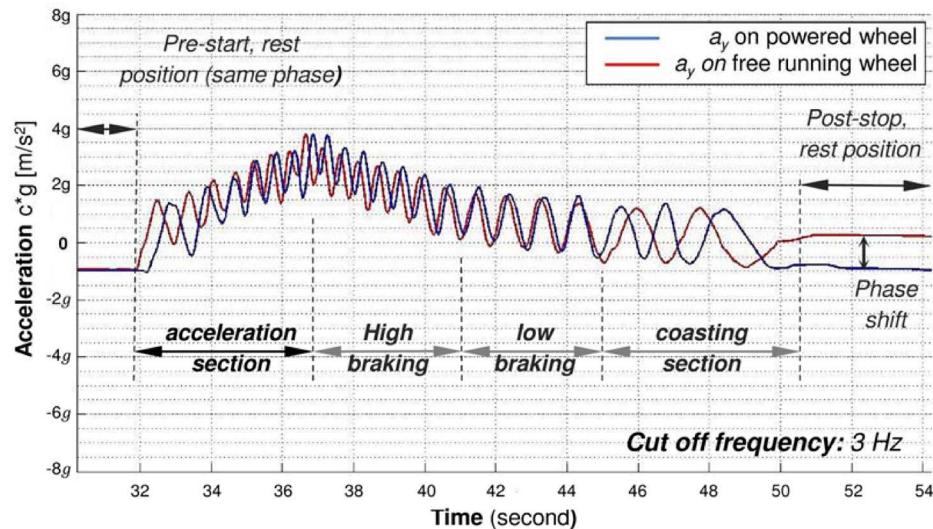
Figure 8 Centrifugal acceleration of powered and free running wheels
