# Condition assessment of concrete structures using ground penetrating radar (GPR)

Ksenija Tešić<sup>1</sup>, Asst. Prof. Ana Baričević<sup>2</sup>, Asst. Prof. Marijana Serdar<sup>3</sup>

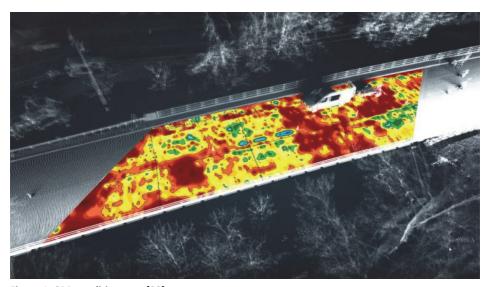
agreement was established between these two methods. Regardless of concrete condition, the amplitude attenuation depends on concrete cover, and so Barnes et al. [23] revealed the depth correction for the reflected amplitude, and the resulted amplitude was then correlated only with dielectric properties of concrete cover. Martino et al. [25] went a step further and used the ROC (Receiver Operating Characteristic) curve to determine the threshold value for the rebar reflection amplitude, which distinguishes corroded from healthy areas, and a high accuracy between HCP and GPR method was established. Also, the attenuation of the GPR signal was used to monitor the progress of deterioration at the concrete bridge deck by comparing results from various surveys conducted over two years [26]. The attenuation map was compared with the map of electrical resistivity of concrete, and the authors attributed strong correlation between these methods to the fact that both of them are primarily subordinated to the electrical conductivity of concrete. Besides, the GPR results were used for assessing the overall condition of concrete decks by calculating the GPR condition index (CI), which is the indicator of the level of deterioration [27]. It can be combined with other condition indices obtained with other NDE methodologies for assessing condition of bridge decks [28]. As an example, the GPR condition map obtained with the robotic survey is shown below.

Figure 4. GPR condition map [28]
